ENVIRONMENTAL TEST REPORT

Tal-Shir Ilan Bar Ltd

STOPPER

Document Status	Released
Document Revision	--
Document Number	2122A10380

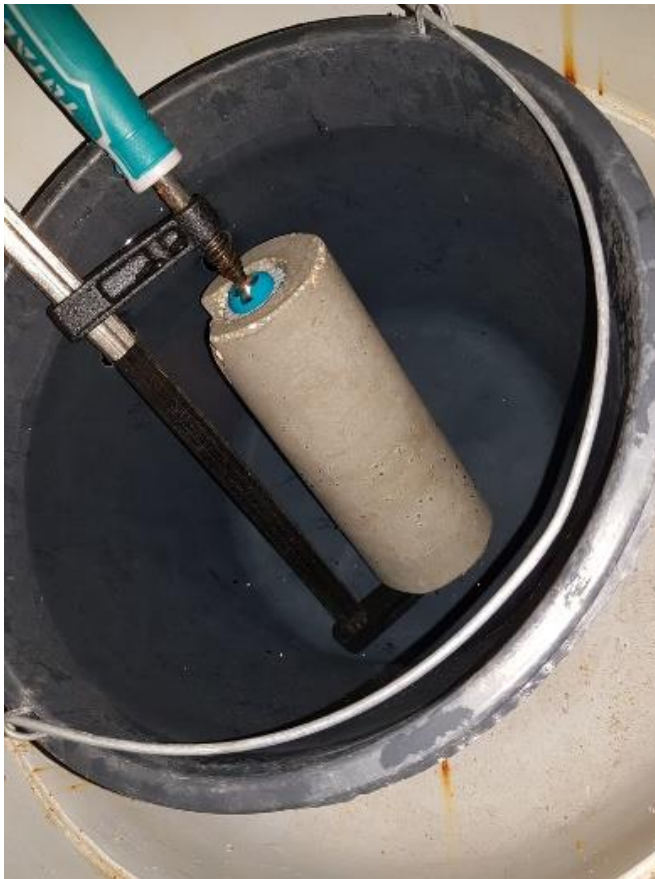
Figure 2.1 - UUT during Immersion Test

- The 70 mm concrete cylinder was sealed from each side with 2 Stopper units.
- The sealed 70 mm concrete cylinder was **immersed with water** and inserted inside the pressure chamber.

- After 6 hours a visual inspection performed, **No evidence of water penetration** observed inside the 70 mm concrete cylinder.

In visual inspection at completion of the test, no evidence of water penetration observed inside the cylinder.

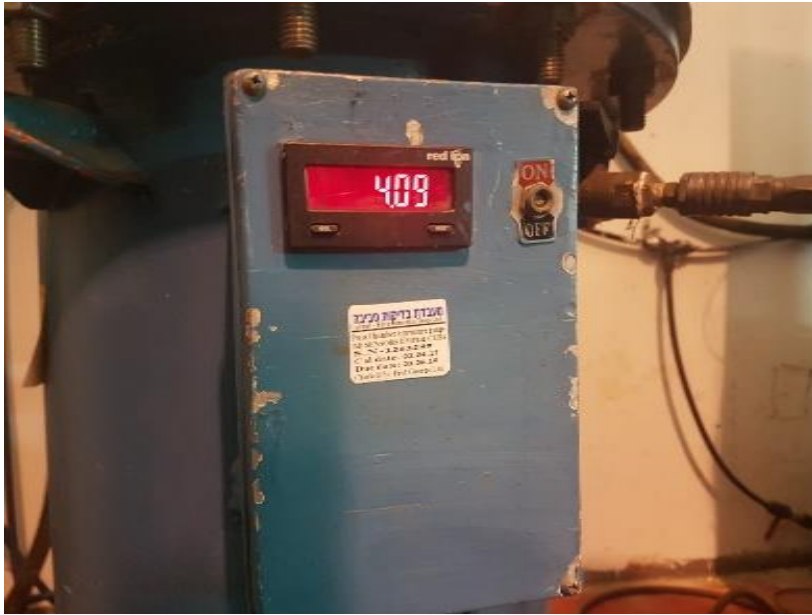
Figure 2.2 - Chamber Pressure

- The chamber pressure raised to **5Bar** (1 Bar of atmospheric pressure + 4 Bar on the chamber) for a duration of **30 minutes**.
- After 30 minutes, a visual inspection performed, **No evidence of water penetration** observed inside the 70 mm concrete cylinder.

- The 70 mm concrete cylinder was sealed again, immersed with water and inserted inside the pressure chamber.
- The chamber pressure raised to **5Bar** (1 Bar of atmospheric pressure + 4 Bar on the chamber) for a duration of **6 hours**.
